## HiPo dropped scaffolding kickboard

<b>Number</b>	2020-03	<b>Date</b>	16.07.2020
---------------	---------	-------------	------------

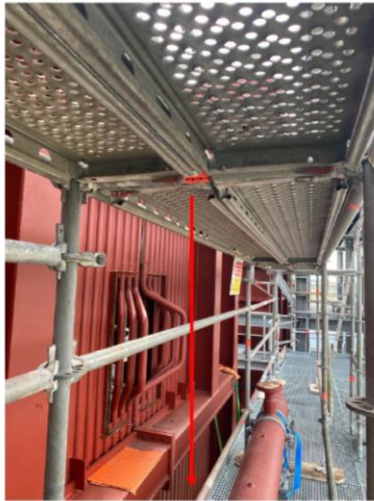
Recently during the construction of an energy from waste plant a scaffold kickboard 2m long and 15cm wide (about 3kg) fell through a small gap between a boiler and walkway and struck a worker on the head 5m below. The worker was not injured. The scaffolder who had removed the board that fell was instructed to carry out a minor modification to the scaffold by an erection contractor supervisor. Individual scaffolders working directly with contractors was adopted by HZI to prevent unauthorised modifications to scaffolds by erection contractor workers when they needed access for pipes or lagging to be installed. In this case though no exclusion zone was put in place below the work and the scaffolder failed to notice the gap.

Arrow shows small gap

- Revise RAMS to include requirement to inform Scaffold Supervisor so that the Supervisor can take responsibility for the activity and implement the correct controls
- If a Drop Zone is required the Scaffold Supervisor must ensure that the Drop Zone is approved by HZI and detailed on the POWRA. It can then only be removed by Scaffold supervisor Supervisors who annotates the POWRA.

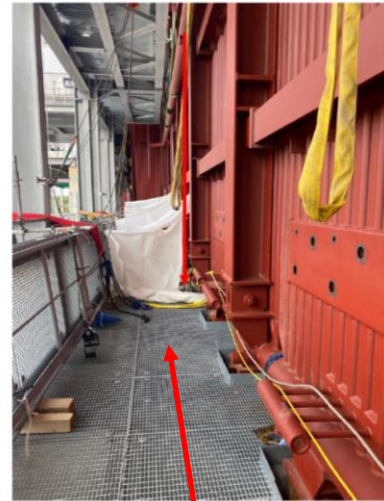
Position of worker 5m below
