| | <div style="display: flex; align-items: center; justify-content: center;"> <div style="text-align: center; margin: 0 10px;"> LESSON LEARNED </div> </div> | Doc. No.: GP426 F39 Rev. 01 |
| Hitachi Zosen Inova | | |

| Number | 2024-10 | Date of Issue | 03.05.2024 |
| Date of Incident | 13.04.2024 | Incident Classification | Property Damage - HiPo |

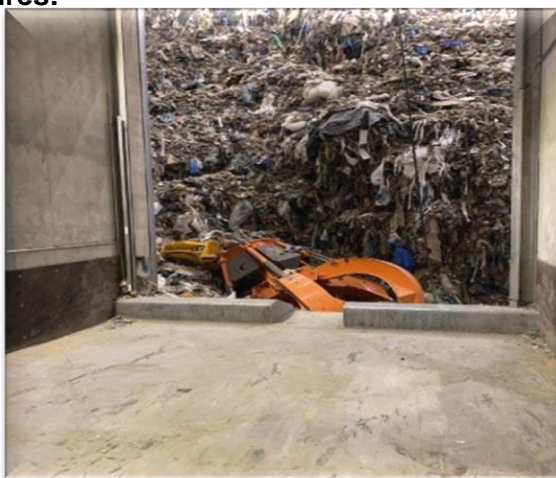
During commissioning at a UK construction, the waste crane 2 operator was working on waste transfer within the bunker. When lifting the waste and traversing the crane the grab began to Swing. The operator attempted to stop the swing by lifting the grab, during this operation the 11 tonne Grab struck the main support beam of the crane causing the crane cable to snap. The grab fell opposite a bay with an open door where there was an O & M operative cleaning nearby. It was determined that the crane operator was using the waste crane 2 in manual mode at the time of the incident.

Viewed from the Tipping Hall

| Root Cause and Contributory Factors | Lesson Learned |
|--|---|
| <p>Immediate/Direct Cause</p> <ul style="list-style-type: none"> In an attempt stop the grab from swinging and spinning the crane operator lifted it too quickly allowing the grab to strike the support beam snapping the cable <p>Contributory Causes</p> <ul style="list-style-type: none"> Fatigue, Operator had done 5 days of shifts. Time pressures: The crane operated at full speed to prepare the bunker prior to more deliveries. The bunker was full because the plant continued to receive waste during an unforeseen shutdown. The profile of a full bunker meant limited space for grab movement. There is no evidence of a lesson plan, learning outcomes or structure to the waste crane training. Although the disabled interlock did not contribute to the failure of the crane cable it was a contributory factor in the HiPo incident category incident due to the proximity of a worker to the open door. <p>Root Cause</p> <ul style="list-style-type: none"> Training – Improvement – Instruction/ proficiency testing | <p>Competency Training</p> <ul style="list-style-type: none"> Crane Contractor to review training package to include a lesson plan, learning outcomes and test criteria, HZI to monitor for future projects to demonstrate that the agreed HZI training Programme is being followed All HZI O & M team previously trained get structured refresher training from the Crane Contractor. HZI to verify compliance of provider training with HZI standards and requirements. <p>Documentation</p> <ul style="list-style-type: none"> O & M team to review the door interlock system and override procedures. |

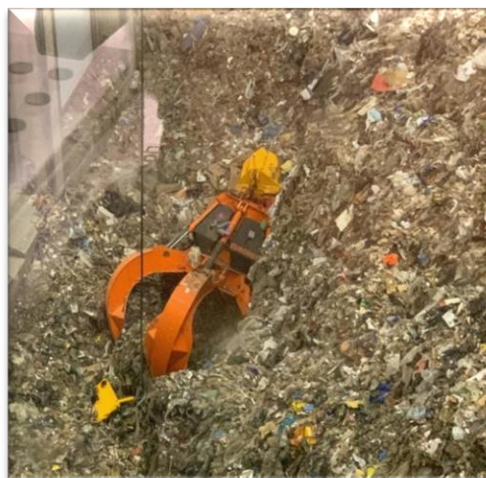
Viewed from the Control Room
