LESSON LEARNED  	Doc. No.: GP426 F39 Rev. 00
Hitachi Zosen Inova

Environmental – LTI Broken arm by manual handling without mechanical aids			
Number	2022-09	Date	20/07/2022
<p>Summary: At the time of the accident, the IP was assigned to install components in a system skid. In the scope of these activities, a valve block weighing approx. 60 kg also had to be installed. To move the valve block, the IP does not use the existing overhead crane, which is usually used for transporting and positioning heavy components. Instead, he tried to carry the valve block to the installation site by hand. While trying to lift the valve block into the rack, he lost his balance and the valve block slipped away.</p> <p>Outcome: Broken elbow bone in the right forearm</p> <p>Incident Classification: LTI , Level 2</p>

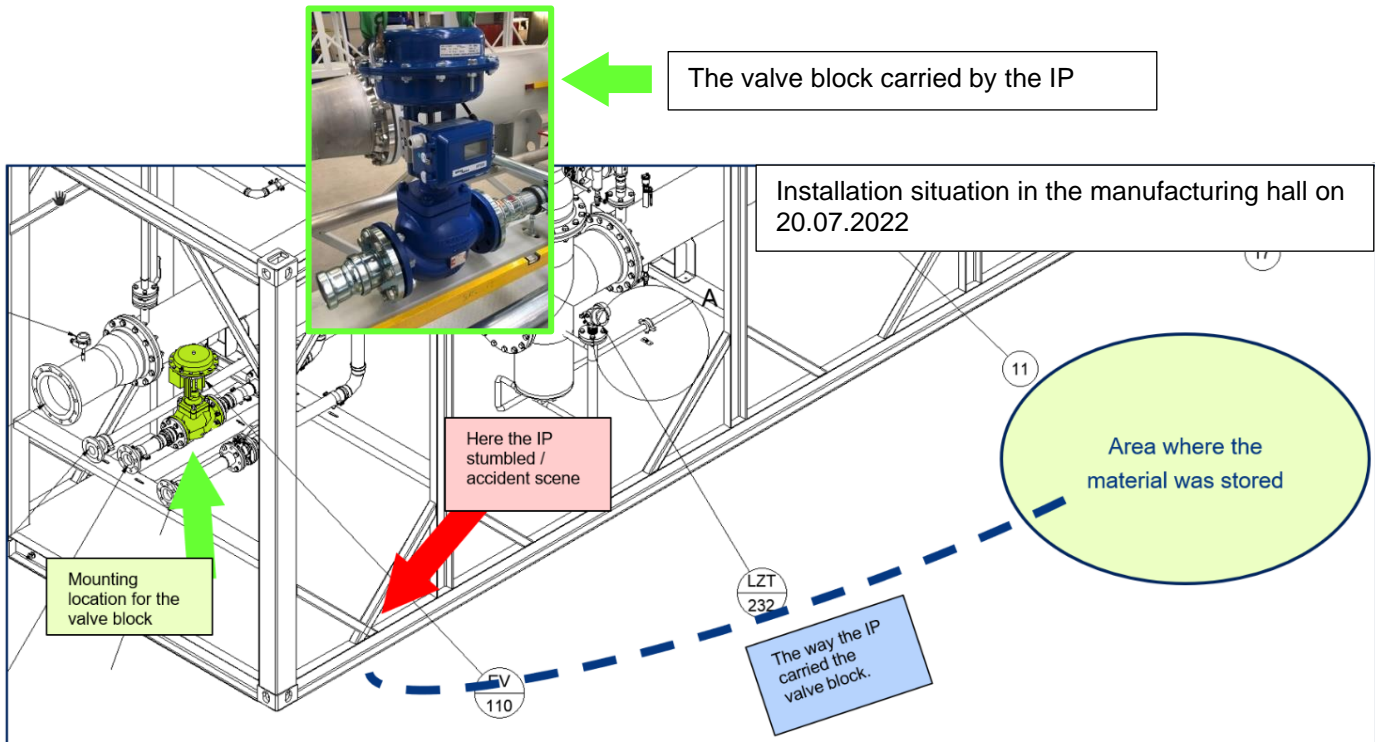
Root Causes and Contributory Factors	Lesson Learned
<ul style="list-style-type: none"> • Stumbling while carrying a heavy load. • Non-compliance with safety measures and relevant Method Statement & Risk Assessment for handling heavy loads. • Lack of Risk perception. • The combination of new work tasks and low staffing levels coupled with increased time pressure can be seen as an additional hazardous factor. 	<p>The accident could have been avoided if the available tools had been used. The non-use of these tools indicates that the IP misjudged the dangers of his actions. This in turn may indicate that the IP's awareness of HSE was insufficient. Therefore, please note:</p> <ul style="list-style-type: none"> • Always check that you are carrying out the work safely. • Ensure the task is executed as per approved RAMS, otherwise engage your leader to revised it together with your HSE person in charge. • Do not take any short cut • Always follow manual safe handling techniques
