<div style="display: flex; align-items: center; justify-content: center;">   <div style="text-align: center; margin: 0 10px;"> <b>LESSON LEARNED</b> </div>   </div>	<b>Doc. No.:</b> <b>GP426 F39 Rev. 01</b>
<b>Hitachi Zosen Inova</b>

<b>Number</b>	2023-20	<b>Date of Issue</b>	20.09.2023
<b>Date of Incident</b>	17.07.2023	<b>Incident Classification</b>	Environmental Incident L1

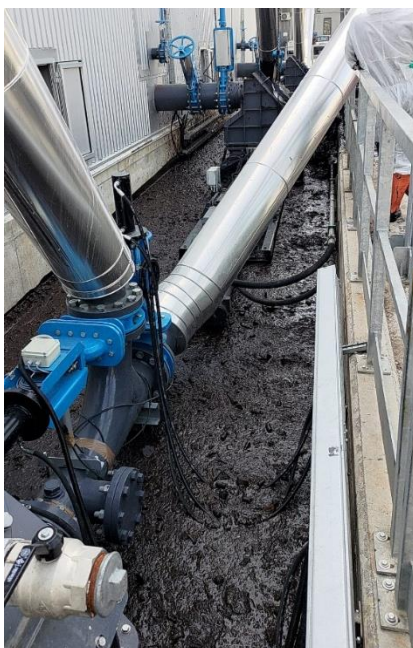
**Summary:** On 17.07.2023, in one AD project in Italy, the discharge pump was blocked. Manual intervention was required to unblock the discharge system. On the day of the incident, an HZI Maintenance Manager was on site. However, he had to leave the site to assist with another project. After contacting the HZI Commissioning Manager, they both agreed that Industrial Projects ( a company already on site) could carry out the task following the procedure for emptying the hopper (HZI Doc No: 50182192). Before leaving the site, the Maintenance Manager closed one of the two DN400 main valves.

While carrying out the task, the operator, for unknown reasons, reopened the closed DN400 main valve and did not follow the procedure. As a result, the spill occurred when he opened the hopper cleaning flange. The operator then used the hydraulic manual pump to close the DN400 valve. He then informed HZI of the incident.

**Outcome:** The spilled digestate material was banded within the discharge basin and the spill didn't reach the ground. The spilled material was collected by a suction truck and disposed into the bunker.

<b>Root Causes and Contributory Factors</b>	<b>Lesson Learned</b>
<p>Root causes:</p> <ul style="list-style-type: none"> <li>• Procedure not followed</li> </ul> <p>Contributory factors:</p> <ul style="list-style-type: none"> <li>• HZI personnel not present on site</li> </ul>	<ul style="list-style-type: none"> <li>• For all repairing works in the discharge system ensure that HZI personnel is present on site.</li> <li>• Follow the relevant HZI procedures/method statements in detail.</li> <li>• Print the HZI procedures/method statements and use them as a checklist (check that each step was followed)</li> <li>• Apply LOTO as per AA42613 procedure</li> <li>• Implement a Permit to Work system as per AA42613 procedure</li> <li>• Modify the design of the DN 400 main valve covers to ensure that operators can visually confirm that the valves are closed.</li> </ul>

<ul style="list-style-type: none"><li>• Ensure that operating personnel received the relevant training</li></ul>
