HiPo Near miss: Flashing Sheet falls 14

| <b>Number</b> | 2020-04 | <b>Date</b> | 30.07.2020 |

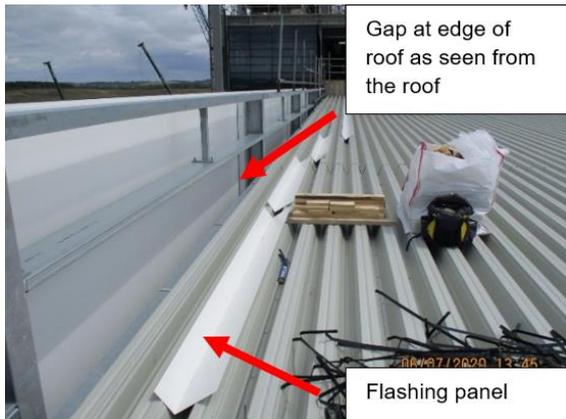
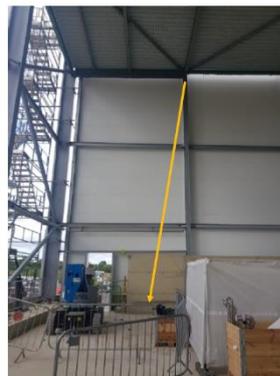
Recently during the construction of an energy from waste plant a scaffold a second near miss occurred involving a large item of construction material falling through a small gap. This incident involved a right angled sheet of flashing used to weatherproof the corners of roofs. The flashing sheet was approximately 3m long and weighed 30kg. It was about to be installed between the roof cladding sheets and the vertical parapet wall sheets. The gap that the sheet was covering was 320mm, it ran along the length of the roof directly above the inside of the tipping hall. There were no controls in place to protect workers below when the first panel was installed. Two operatives were assigned to fit the sheets but one was not at the workface so a single operative attempted to fit the sheet which dropped through the gap and no supervisor in the area. The sheet fell into an area where another contractor had been working shortly before.

- The supervisor had not noticed the gap or put any controls in place to prevent dropped objects.
- The supervisor was not present when the job started to check that other controls were adequate.

- The operative attempted to fit the heavy flashing sheet on his own.

- Check that Point of Work Risk Assessments are correctly implemented and conducted and the Hazards in the work area have been identified and controls put in place.
- Ensure that the level of Direct Contractor Supervision is suitable for the work taking place especially at the start of a new work activity
- Consider the need for an exclusion zone/drop zone for ever activity taking place on site.
- Ensure the Drop Zone is approved by HZI
