HiPo LTI: Explosion of a PVC pipe

Number	2020-06	Date	August 10th, 2020
---------------	---------	-------------	-------------------

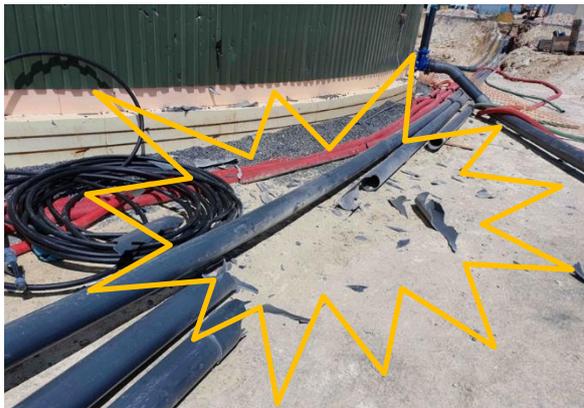
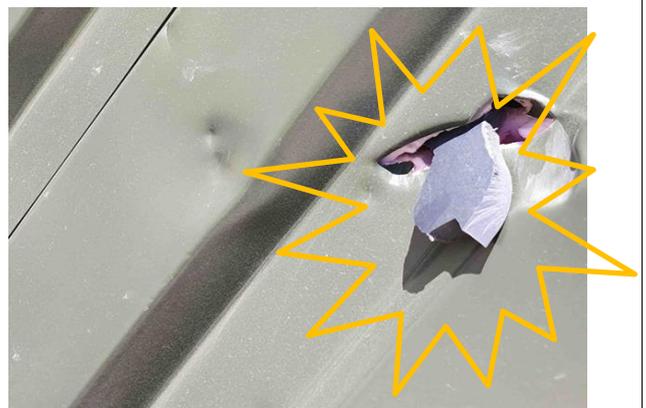
Photos

Summary: On Thursday July 9th 2020, an explosion took place in a Biomethane project located in France. The work underway at the time of the incident was the plasma arc welding on a stainless-steel elbow which was connected to a 160 mm PVC pipe. The PVC pipe elements had been glued 2 days before with a special adhesive but not vented before being connected to the stainless-steel elbow. Due to that the fumes released by the adhesive cumulated inside. When the hot work started, the open flame of the arc plasma ignited the flammable fumes. As a result, the ignition flowed along inside the PVC pipe, which blasted at a distance of approximately 12m away from the elbow. Fragments of the pipe were scattered around, damaging the surrounding pipes, and some of them penetrated the cladding of the post digester. The incident didn't cause any injuries to people, only limited property damage. However, in other circumstances, it may have resulted in major consequence, therefore it is classified as a high potential incident (HiPo).

- Procedures not followed:
- HSE recommendations stated in the MSDS of the adhesive not followed.
 - Last Minute Risk Assessment (POWRA) not implemented.
- Procedures not available:
- RAMS for the activities not prepared.
- Lack of Coordination:
- Coordination meetings with HZI and the involved Subcontractors not conducted.

- Ensure that Site Coordination meetings with HZI and Subcontractors are held on a regular basis and recorded.
- Check that POWRAs are correctly implemented and the hazards in the work area have been identified and controls put in place.
- Ensure that RAMSs for each activity have been prepared and implemented at site.
- Ensure that MSDS recommendation are taken in account and controls implemented.
