LTI: Electric drill injury

Number | 2020-08

Date | November 11th, 2020

Summary: On Thursday October 9th 2020, approximately at 14:00, an incident took place in a Biomethane project located at Grand Chapelles, France.

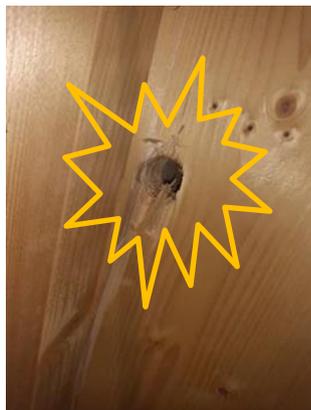
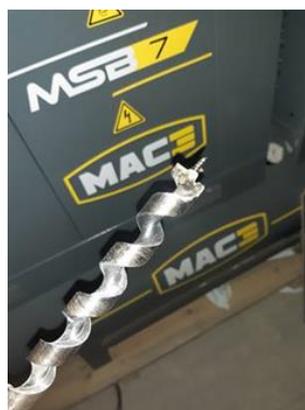
Photos

The work underway at the time of the incident was being performed by an HZI's Subcontractor, with the purpose of drilling of a hole on a wooden wall inside the pump room in order to install a cable duct. The activity was carried out by two electricians, one on each side of the wall. Once one of them approached the wooden wall to remove the chips from inside the hole, his colleague on the other side resumed the drilling. The drill bit hit the left index finger of the injured person, causing a cut on it.

The injured person needed medical attention and the wound was treated with 12 stitches.

- Last Minute Risk Assessment (Take 5) not implemented.

- No method statement and risk assessment (RAMS) for such activity was available

- Lack of risk perception
- Lack of communication

- Implementation of Last-Minute Risk Assessment with Take 5 tool by subcontractors at site to raise risk awareness and implement control measures.
- Ensure that RAMSs for each activity have been prepared and implemented at site.
- Shielding of the drilling area by means of barriers in order to create an exclusion zone around the risk.
