LTI: Back pain and minor leg injury

Number | 2021-01

Date | January 19th, 2021

Summary: On Tuesday January 19th 2021, approximately at 11:40 AM, an incident took place in a Bio-methane project located at Wittenburg, Germany.

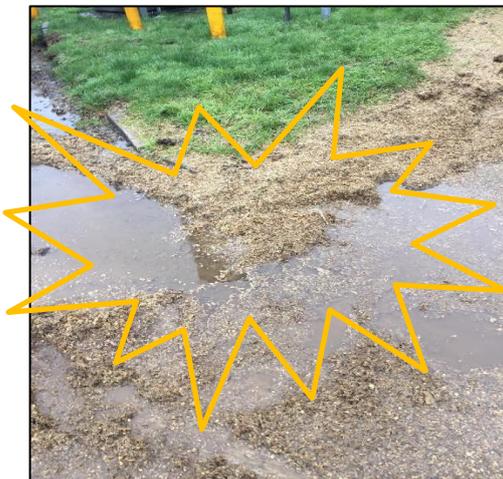
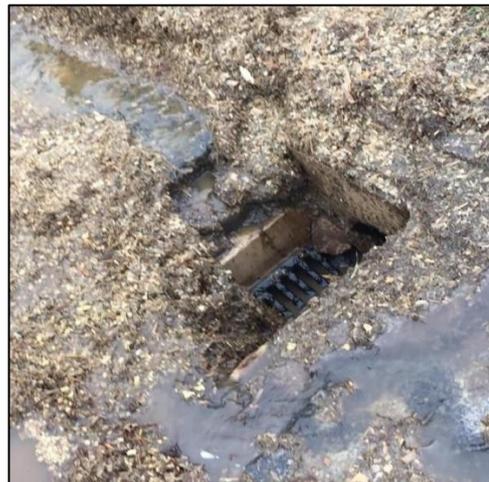
On his way to the house, he stepped into an open drain covered by water and silage.

- Lack of housekeeping (water puddle and silage not removed timely).
- Lack of communication (drain was not signaled nor barricaded).
- Lack of controls (drain cover was not installed).
- Lack of risk perception (IP was not aware of possible hazards beneath the water puddle).

- Instruct employees to refrain from entering areas whose condition cannot be accurately assessed and could have hidden hazards.
- This point should also be included in the general RAMS to be created for service activities.
- Share with owners the lesson learned of this incident in order to implement the defined corrective actions.
