LTI: Fitter Injured By A Flying Actuator Component

Number	2021-06	Date	September 9 th , 2021
---------------	---------	-------------	----------------------------------

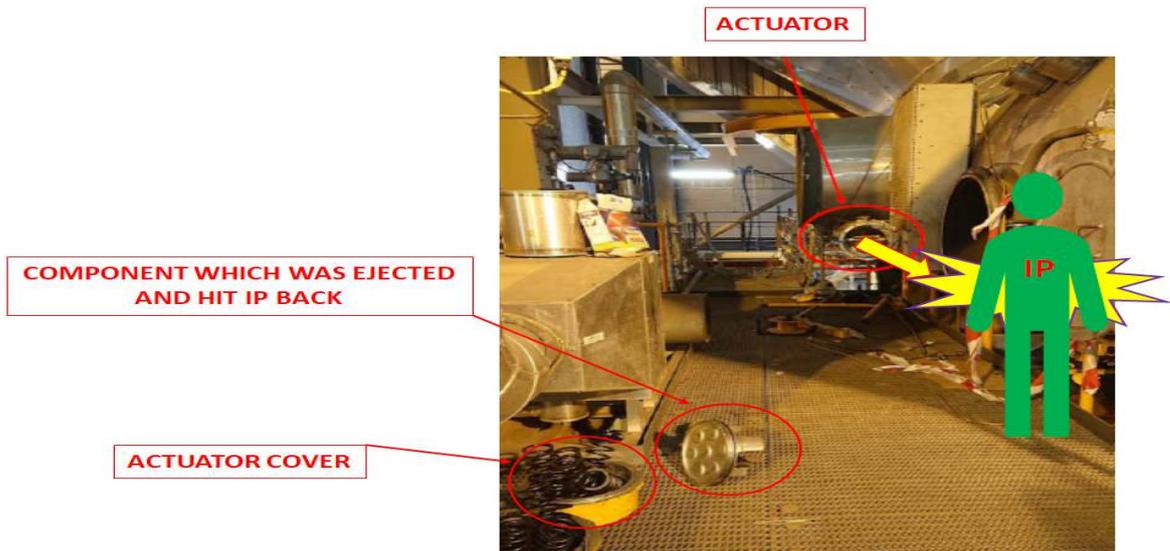
A part of an actuator of a flue gas damper, which was located beside the IP flew out and hit his back at high speed.

The actuator was pressurized with air at 8 bar and its cover had been removed earlier that day by another contractor also working for the Client.

Due to the pressure, the actuator component was suddenly ejected away and reached the fitter's back.

- Lack of communication (between the different contractors working at site for the Client).
- Procedure not followed (actuator's Manufacturer recommends to remove the whole actuator and not to dismantle it).
- Procedure not implemented (isolation and LOTO not applied on the source of energy of the actuator).

- Daily coordination meetings with Client and all contractor to be held in order to identify and manage all simultaneous activities, which may create additional risk on the work-front of each of them. Discuss the outcomes during POWRA.
- Ensure that Manufactures recommendations are followed anytime and do not deviate from such instructions.
- Isolation / LOTO procedure to be implement any time on energized systems
- Share with Clients the Lesson Learned of this incident in order to implement the defined corrective actions.
