**Env/Near Miss – HiPo UNCONTROLLED SPILL OF RESIDUE ASH**

<b>Number</b>	2021-07	<b>Date</b>	22.09.2021
---------------	---------	-------------	------------

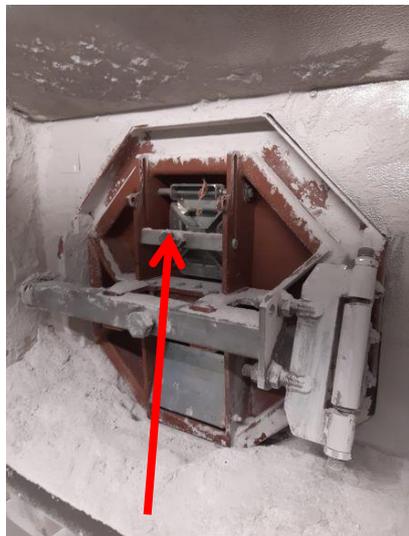
**Small Inspection Opening**

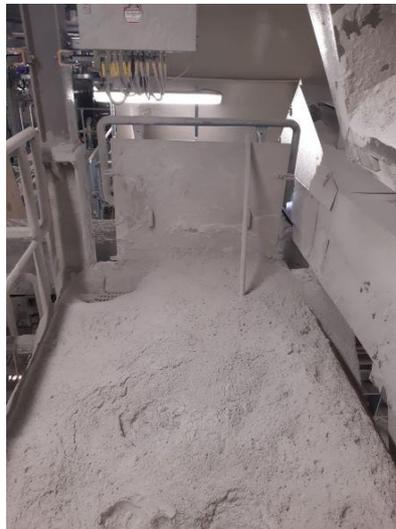
**Walkway Under Door**

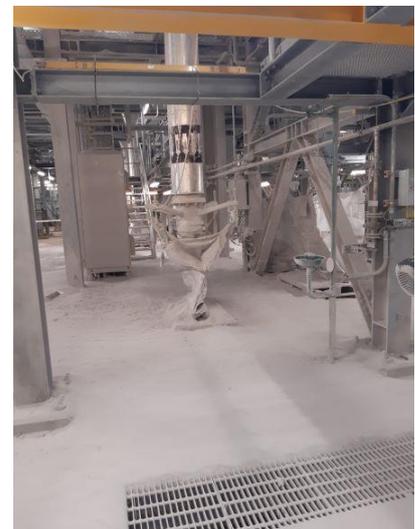
**FGT Ground Floor Level**
