**LTI: Metal Dust in eye**

**Number** | 2022-01

**Date** | January 10<sup>th</sup>, 2022

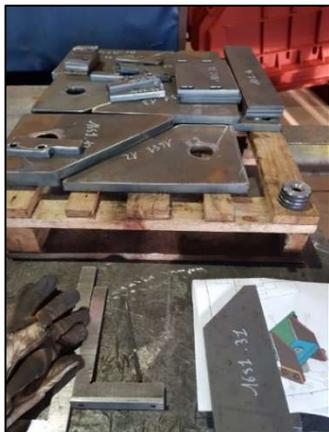
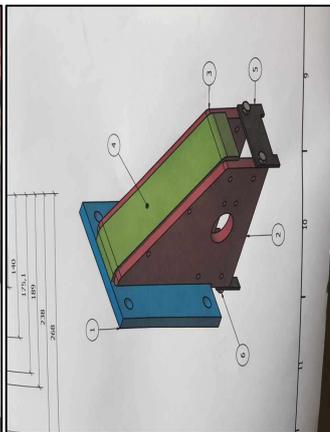
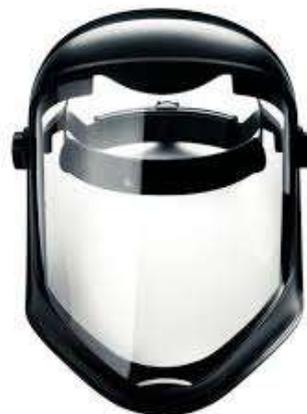
**Photos**

During a grinding operation, supposedly, the IP received a flying metal object in his right eye.

- Procedure followed incorrectly
- Lack of Risk Perception
- Lack of training

- Ensure that control measures identified in the Risk Assessment are shared with the workforce and implemented.
- Wearing safety glasses and face shield during grinding chipping activities
- Ensure that a Point of Work Risk Assessment (TAKE 5) is carried out before commencing activities.
- Ensure PPE are periodically cleaned to avoid dust or residues to be accumulated into them.
- Ensure HSE training session for grinding, welding and oxy cutting operations
