**Near Miss – HiPo DROPPED OBJECT**

<b>Number</b>	2022-02	<b>Date</b>	11.02.2022
---------------	---------	-------------	------------

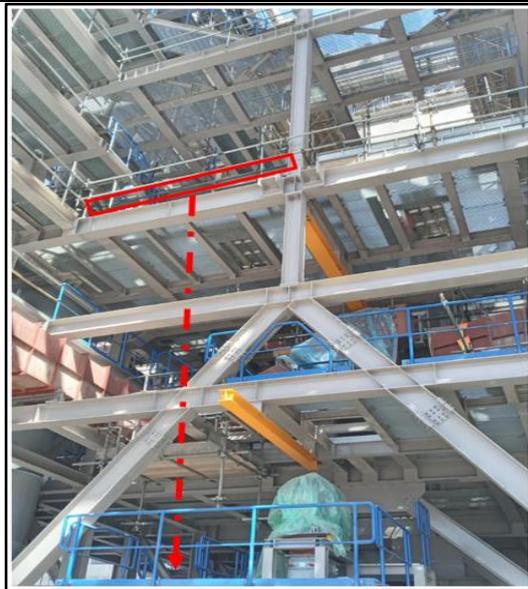
**Scaffold toe board fell 11m to the ground**

- The two standards provided (punching) for the scaffold metal toe board did not have adequate length as per the accepted scaffolding requirement. The standards did not extend to the grating platform in order to add firm support to the toe boards.
- A wooden dunnage used for the storage of a boiler pipe spool was kept very close (about 10mm) to the scaffold metal toe board in such a manner that it may induce constant pressure on the fittings of the toe board.
- The scaffold metal toe board was secured only with 1 clamp instead of the required 3 clamps.
- There was no inspection system in place in order to confirm the integrity of provided temporary edge protections (toe boards).

- Where the length of the toe board is >2.5m, 3 clamps should be used
- The standards (punching) of the toe board should be extended to the grating platform level to add firm support to the toe boards.
- When placing dunnage or supports, it must be kept away from any edge protection (toe board).
- Only trained and competent scaffolders can make erection, dismantling or alteration of any scaffold structure.
- Implement a regular (weekly) inspection system – similar to the traditional scaffolding inspection process to check and confirm the strength and integrity of temporary edge protections (toe board).

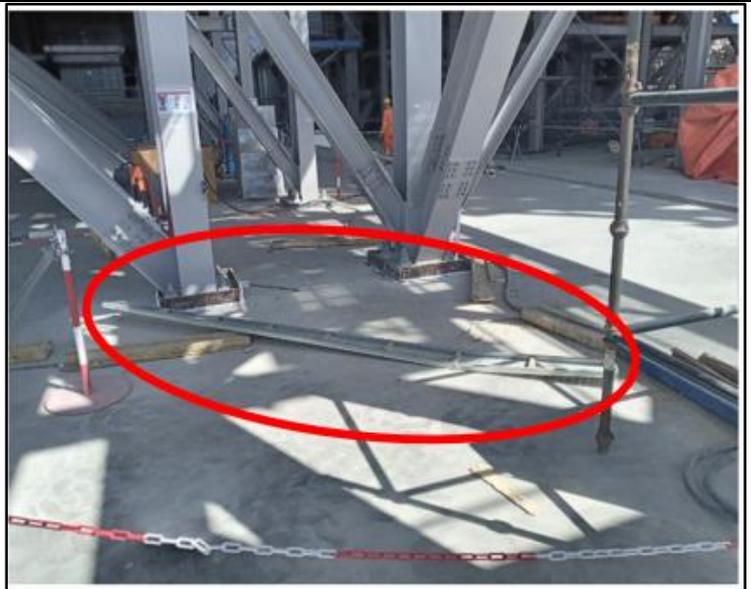
**Scaffold metal toe board landed at this position next to the mason crew**
