<b>Number</b>	<b>2022-05</b>	<b>Date</b>	<b>30.06.22</b>
---------------	----------------	-------------	-----------------

**Summary:**

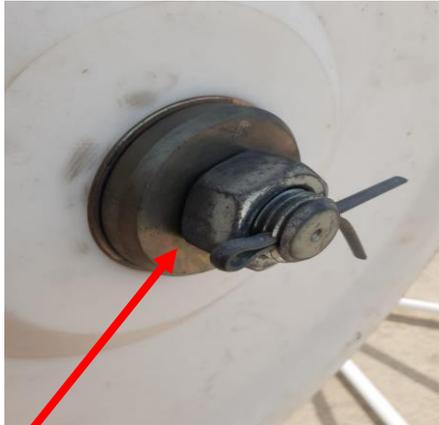
Another sheave on the same jib

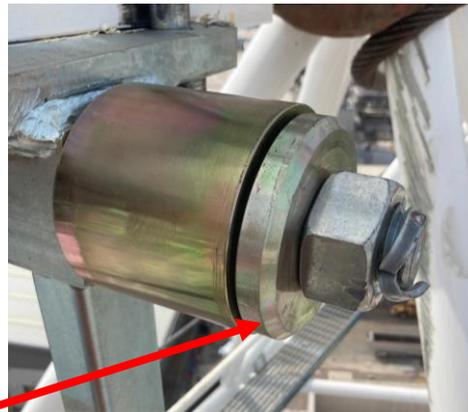
Bearing of the detached sheave

The erection sheave washer installed to prevent the sheave coming off from its housing was too small, which resulted in it riding over the locking nut and the sheave falling to the ground.

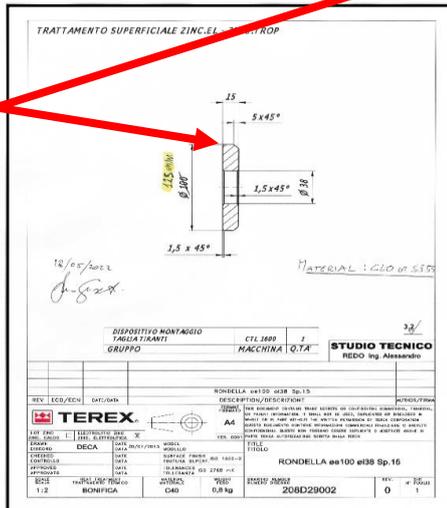
Incorrect Washer

Correct Washer

Replacement washer fitted to sheave

- Correct sized washer using updated drawing was manufactured and installed onto HZI Crane
- Crane manufacturer is reviewing internal processes to make their checks at design/assembly level more robust
- Crane manufacturer issued a global safety alert to inform all customers of the incorrect sized erection sheave washer and the correct parts to be fitted
- At site level ensure that any exclusion zone is big enough to encompass the effect of dropped objects which do not fall vertically.
- Prestart inspections are key to identifying and preventing similar incidences.
