**Near Miss – HiPo DROPPED OBJECT**

<b>Number</b>	2022-10	<b>Date</b>	28.07.2022
---------------	---------	-------------	------------

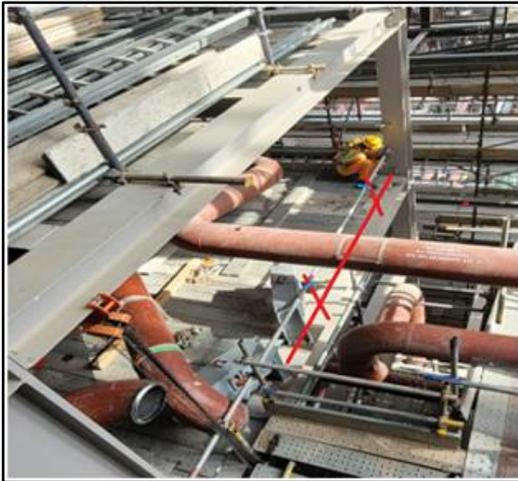
Mid rail and puncheon fell from 23m elevation

- The puncheons of the scaffolding was only secured on the top rail with two swivel couplers. They were not secured on the existing structural steel beam.
- The scaffolders did not examine the scaffolding structure which need to be modified prior to starting the modification activity. The examination would have revealed if the immediate integrity of the structure would be affected by the modification.
- There was poor work arrangement/planning by the scaffold modification team as they were working under the EDRA/T-Card of another team which did not cover their scaffold modification scope of work.
- There was no dedicated scaffolding supervisor provided for the scaffold modification activities.

- The scaffolders and scaffold inspectors should ensure that all scaffold structures are adequately erected with appropriate anchorage/couplings attached.
- All scaffold modification activities should be supervised by a competent scaffolding supervisor.
- Adequate safe system of work including appropriate Drop Zone should be established prior to the start of any scaffold modification activity.
- Prior to starting any modification of a scaffold structure, the scaffolders should examine/survey the structure to ensure that the modification will not jeopardise the immediate integrity of the scaffold structure.
- Only trained and competent scaffolders can make erection, dismantling or alteration of any scaffold structure.

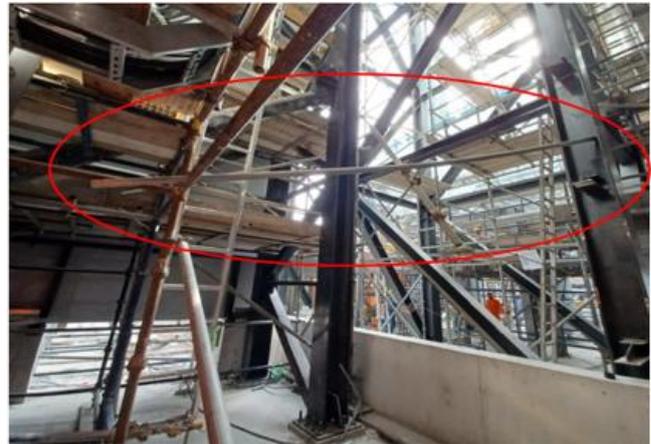
Mid rail and puncheon final landed position
