**LTI – Zurich Laboratory – Cut on head**

<b>Number</b>	2022-17	<b>Date</b>	15.12.2022
---------------	---------	-------------	------------

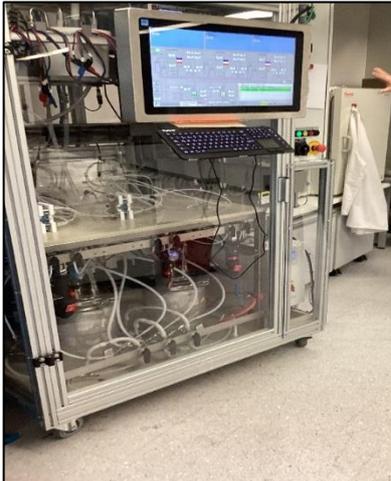
**Summary:** On November 30<sup>th</sup>, the Injured Person started some repair works on an the electrolysis machine in HZI Zurich Laboratory.  
As a part of the activity, IP needed to bore 4 holes on a metal panel with a drill.  
He placed the metal panel on the ground and, standing up with his weight on the drill, he began drilling.  
Suddenly the drill bit broke causing the IP to lose his balance and hit his head on a sharp edge of the electrolyser’s frame.

Picture 1 - Electrolysis test bench (overview)

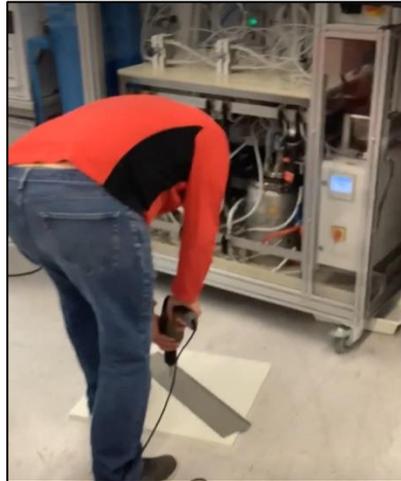
Picture 2 - Position of IP during the drilling (simulation)

- Lack of Procedure (activity not covered in Risk Assessment)
- Lack of Risk Perception (IP didn't perceive the risk of falling forward and hit his head)
- Work Preparation (the activity started without a previous proper organization, adopting a wrong posture, and not taking in consideration ergonomic aspects).

- Provide the necessary materials and equipment (i.e. a work bench) to be used for such activities (as drilling and other maintenance works) ensuring correct posture.
- Risk assessment to be revised. Maintenance activities on electrolyser to be included. Relevant risks and mitigations to be considered. Ergonomic aspect to be considered as well.
- Sharp edges protection to be provided, where applicable.

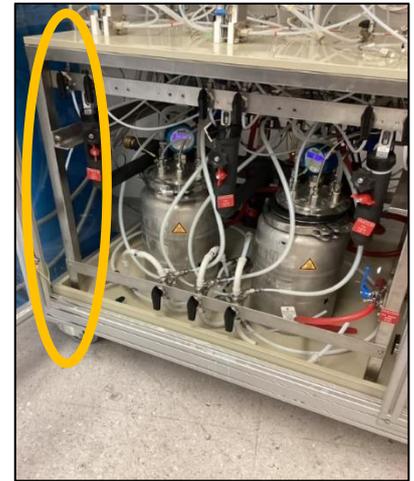
IP suffered a cut on his head which required medical attention. The physician applied 6 steri-steps on the wound and recommended 5-days rest to IP.

Picture 3 - Metal frame with sharp edges.
