Number	2023-26	Date of Issue	22.12.23
Date of Incident	22.11.2023	Incident Classification	L1 - FAC

Summary:

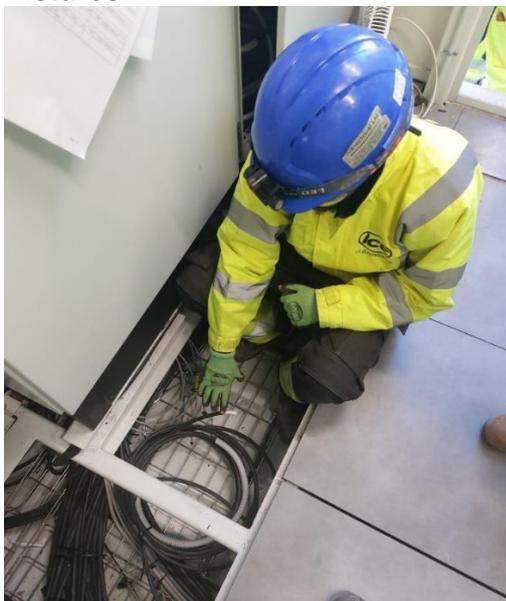
Re-enactment using isolated cable

Root Cause and Contributory Factors	Lesson Learned
<p>Immediate/Direct Cause</p> <ul style="list-style-type: none"> The IP touched a live cable which had been disconnected and left under the floor without insulating the bare conductor. <p>Contributory Causes</p> <ul style="list-style-type: none"> In the TAKE 5 form, the risk of working around energized equipment is not stated. In the electrical commissioning RAMS, Physical checks of equipment is not specified before energisation. <p>Root Cause</p> <ul style="list-style-type: none"> The supplier stated in the Inspection certificate that the transformer and power cable were ready for use, but sent the E-House to the site with the transformer disconnected. 	<ul style="list-style-type: none"> QA to check that suppliers are aware of the requirement to clearly document any changes to equipment condition after certification of testing. Commissioning Rams should include a requirement for a basic physically check of assembled equipment's prior to energising. Once the plant starts to become live, Take 5 POWRAs should detail nature of live services nearby. Even if they are not intended to be worked on. This information will be available from the LOTO Manager.

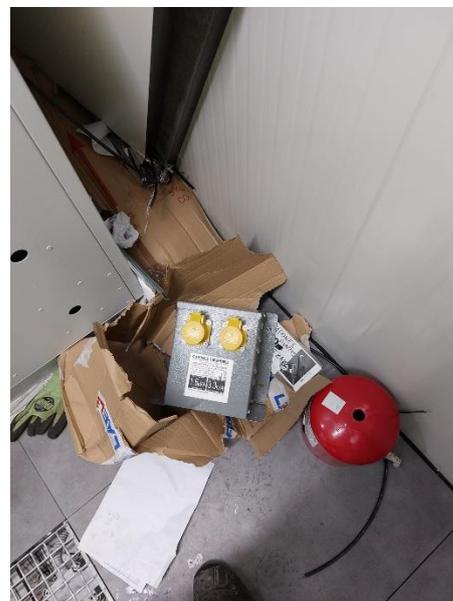
Disconnected transformer boxed for transportation
