| Number | 2024-01 | Date of Issue | 14.03.2024 |

Summary: On 13 December 2023 at 20:47, an explosion occurred at the PtH KVA Buchs project in Buchs in the canton of Aargau, Switzerland. The explosion occurred in the electrolyser container and caused deformation of the venting vessel, container walls and damage to the equipment. At the time of the incident, the plant had been fully assembled and was being commissioned by HZI BioMethan, the supplier of the electrolyser container.

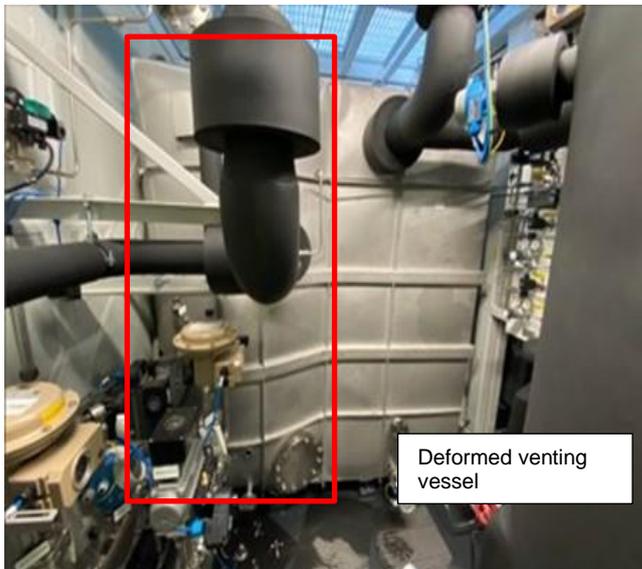
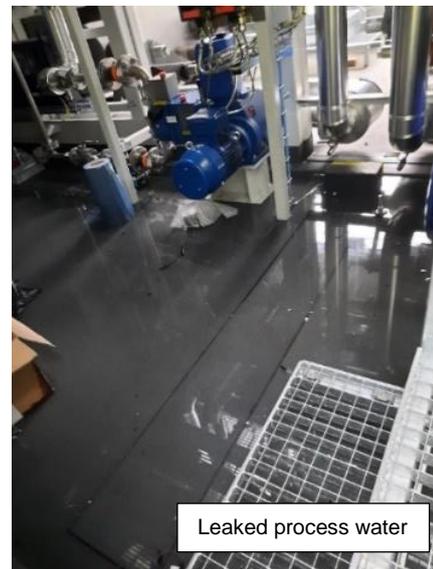
The explosion occurred when a nitrogen purge was initiated, which forced hydrogen gas with a high oxygen gas content into the hydrogen purification unit, called the RTA. The RTA contains a catalyst which burns the residual oxygen in the hydrogen mixture before it is finally stored as purified hydrogen. The explosive mixture reached the RTA, ignited there and then propagated back to the venting vessel where it exploded.

| Root Causes d Contributory Factors | Lesson Learned |
|---|--|
| <p>Root cause: The electrolyser unit had several design flaws that were not identified in the HAZOP.</p> <p>Contributory factors:</p> <ol style="list-style-type: none"> 1. Ambiguous Instructions - Incorrect calibration of the level sensors due to unclear instructions in the manufacturer's manual. 2. Procedures not used - There was no written procedure or RAMS or POWRA detailing the steps to be taken for the ongoing task at the time of the incident. 3. Procedures followed incorrectly - The final design of the plant had been developed in accordance with a HAZOP that was a 'draft' document and had not been approved or signed off. | <ul style="list-style-type: none"> • HZIB engineering business process to be aligned with the HZI AG (BP425). • Re-design the plant taking into consideration the following: <ul style="list-style-type: none"> ○ Prevention of an explosive mixture ○ Prevention of ignition source ○ Explosion proof design • All sensors and similar critical equipment (identified in the HAZOP) to be calibrated by the manufacturer or after specific training provided by the manufacturer. • Commissioning RAMS to be more detailed. • Supplier documentation (O&M task list and Operating Manual) to be received and reviewed by HZI. • Develop new process for pilot projects in PMS or include pilot projects in GP220. |
