Number	2024-06	Date of Issue	23/02/2024
Date of Incident	22/01/2024	Incident Classification	LTI

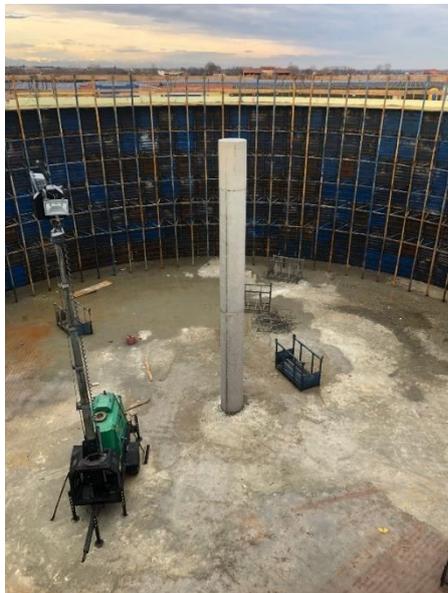
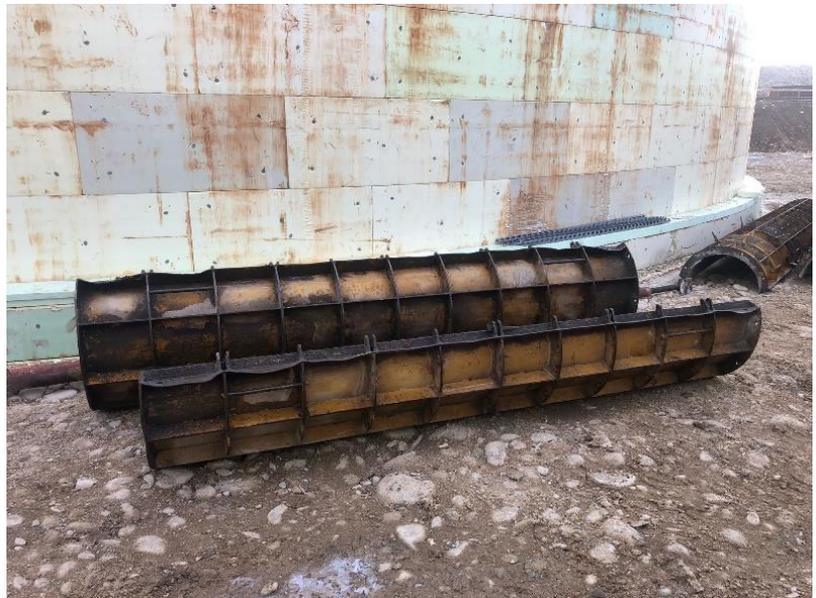
The ongoing activity was stripping the central pillar of a tank, with only half the metal formwork remaining, rigged to the crane (to prevent unwanted wide movement of the formwork, overturning). A worker was using a crowbar as the half formwork was stuck to the central pillar (support of hand tool is an usual practice).

When the formwork got detached from the pillar, the movement was slight as forecasted, as the crane was holding the formworks for safety reasons, but wide enough to touch the right foot of the IP, due to his wrong position, causing a superficial fracture to his right foot.

Root Causes and Contributory Factors	Lesson Learned
<p>Root Cause: Low-risk perception leading to keep a wrong position (Line of Fire).</p> <p>Contributory Factors:</p> <ul style="list-style-type: none"> • Project Procedure / Risk Assessment needs improvement: RAMS did not detailed all possible types of formwork at site. • Pre-job meeting needs improvement: Take5 was not implemented as HZI HSE TII was not attached to contractors' contracts. • Lack of Experience: Worker in young age (20 y.o.), with low experience 	<p>More emphasis and detail on identification and communication of risks and mitigation also in low-risk activities..</p> <p>Procedure to be detailed also for routine activities and when hand tools are to be used.</p> <p>Daily briefing on safety to be more effective, particularly when unexperienced manpower is engaged.</p> <p>Ensure HZI HSE Requirements are part of Contractors' contract requirements.</p>
