Property Damage – HiPo: Waste delivery vehicle tailgate was hit by waste crane

Number	2024-08	Date	06.03.2024
---------------	---------	-------------	------------

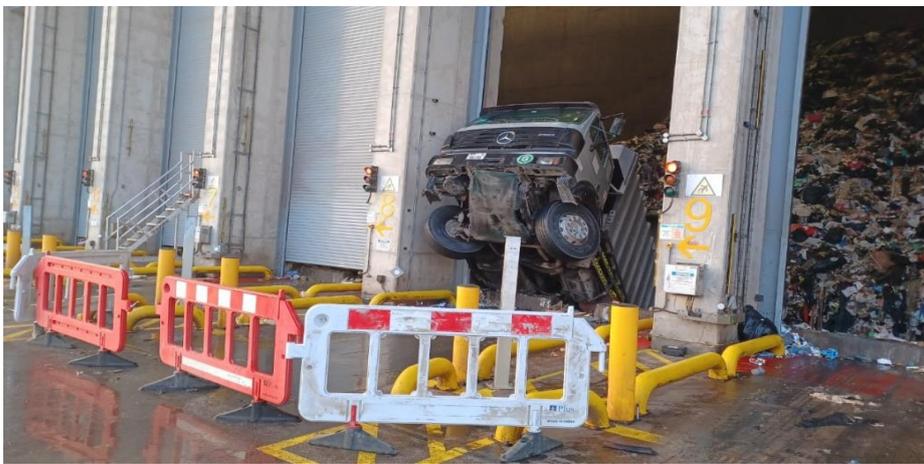
On Wednesday, 06.03.2024, at approximately 06:50 am, a Compactor type waste delivery vehicle belonging to a Waste Operating Contractor was tipping waste in tipping bay# 9, waste bunker #1. Whilst the waste tipping operation was ongoing, the waste crane #2 (which was in automatic operation mode) approached bay #9, struck the waste delivery vehicle's tailgate, and pulled the truck half-way into the waste bunker #1. The waste delivery vehicle driver and his assistant safely exited the waste delivery vehicle whilst it was still in position on the tipping floor. There was no personal injury reported.

Property Damage - The Waste delivery vehicle suffered some damages and the extent of the damages sustained will be confirmed by the Waste Operating Contractor.

Position of waste delivery vehicle during the incident and before rescue, Waste bunker #1, Tipping Bay #9

- **Procedure Followed Incorrectly / Intentionally not followed / Short-cut chosen:** the unauthorised action of tapping the “Reflector” unit of the “Beam-to-Beam light curtain sensor to the “Emitter” unit resulted in the sending of a signal to the crane system “*No obstructions for the light curtain*”, which was a signal that the tipping bay is unoccupied and is available for the waste crane to enter the area, even though the area in question (bay#9) was occupied by the waste delivery vehicle at the time.

- **Communications (No communication or not timely):** failure to report to the SAP that the “reflector” unit of the “Beam-to-Beam light curtain was removed and failure to record this action in any of the permit to work document.

- **Human Engineering (Human-machine interface / Arrangements/placement):** Failure to reinstall the “Reflector” unit after the task was completed
- **Training (instruction Needs Improvement)** the Commissioning Technician was unaware that by tapping the “Receiver” / “Reflector” unit” of the “Beam-to-Beam light curtain to the “Emitter” / “Sender unit” of the light curtain could result in the sending of a signal to the waste crane that the tipping bay is unoccupied even when a waste delivery vehicle is occupying the tipping bay.

- Provide a design control (protection) around the “Beam-to-Beam light curtain” sensor units which will protect the sensors from any potential damage avoid unauthorized removals

- Communicate to all SAP to ensure that any work instructions / precautions / protections being given as part of the approval for a permit to work must be noted/written down within the concerned permit to work document and the information also communicated to the concerned Competent Person.

- Re-emphasis to all workers that they are empowered to intervene by pushing the Emergency Stop Button in the event of any emergency situation.
- Educate all workers to conduct their work activities according to the specific instructions given to them by their supervisor. If there is any change, they must inform their supervisor for authorization to make the change.

- Provide additional training to the HZI BOP commissioning technicians to educate them about the functionality of the “Beam-to-Beam light curtain” sensors including the consequences of any short-cut.
