## Insulation Works – Knife Injury

<b>Number</b>	2022-06	<b>Date</b>	11.07.2022
---------------	---------	-------------	------------

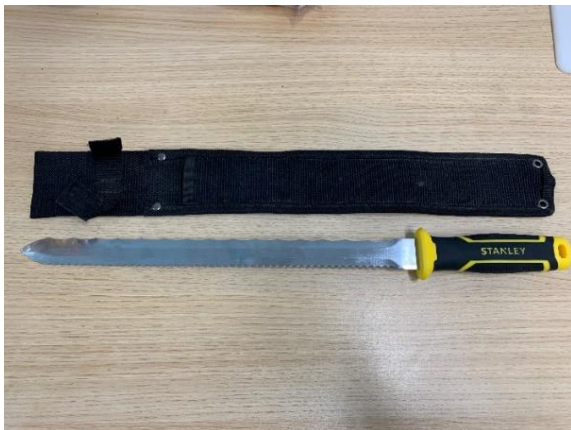
#### Photo

Type of insulation knife being used when injury occurred

- Process
  - Incorrect selection of Insulation knife
- People
  - The IP not sheathing the knife each time it was not in used as documented in the Risk Assessment

- All Stanley Fat Max insulation knives are prohibited on all HZI sites going forwards.
- Only approved “safe knives” for insulation allowed on HZI on sites. These will have one serrated edge, rounded tip and have a sheath / scabbard for storage when not in use.
