**MTC HiPo – CUTTING INJURY WITH ANGLE GRINDER**

<b>Number</b>	2023-01	<b>Date</b>	10.01.2023
---------------	---------	-------------	------------

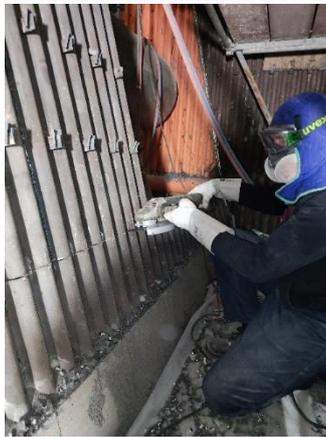
The injured person (IP) was carrying out dismantling work on the boiler in a kneeling position using a large angle grinder. He had to hold the angle grinder at chest or head height. While carrying out the work holding the machine with two hands, the fitter slipped. Due to the relatively heavy weight of the machine and the unfavourable upright position, both of his arms were lowered down by the equipment. He reflexively held the machine with both hands and unfortunately also the machine's control switch then the machine hit his thigh with the still rotating cutting disc cutting his trousers and superficially his thigh. Only then he let go or dropped the angle grinder and then the grinder stopped immediately.

The cutting process with a large, heavy angle grinder in an awkward physical posture

- Implement the TAKE5 system to all employees and subcontractors on site on all shifts and weekend work.
- Ensure adequate Risk Assessment
- Ensure the working areas are always inspected before starting the activities and when the working space is restricted, HSE Dept shall be consulted to ensure the Risk Assessment, working tools/equipment, illumination etc are suitable and the risk is minimized to the lowest reasonably possible level.
- When carrying out the work in difficult/unstable ergonomic positions, plan and implement additional breaks at shorter intervals for the employees to recover.
- Ensure the implementation of mandatory use of the face shields for grinding and chipping activities.

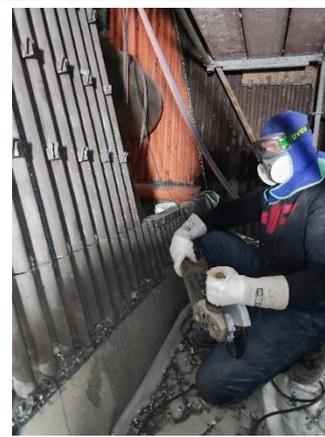
The approximate injury position at the time of the accident

- **Inadequate Risk Assessment**  
The risk analysis did not explicitly address the risks of possible cuts caused by jamming of cutting tools.
- **Lack of risk perception**  
Due to the absence of this hazard in the risk analysis and the non-execution of TAKE 5 during the night shift, the risk could not be perceived properly.
- **Awkward ergonomics** Working with heavy tools (large angle grinder approx. 5.5 kg) while kneeling and using the grinding wheel at chest and head height.
- **Incorrect-PPE:** No use of face shield when using grinding machines.
