2023-07 - LTI WORKER STRUCK IN THE FACE BY HDPE PIPE.

Number	2023-07	Date	10/05/2023
---------------	---------	-------------	------------

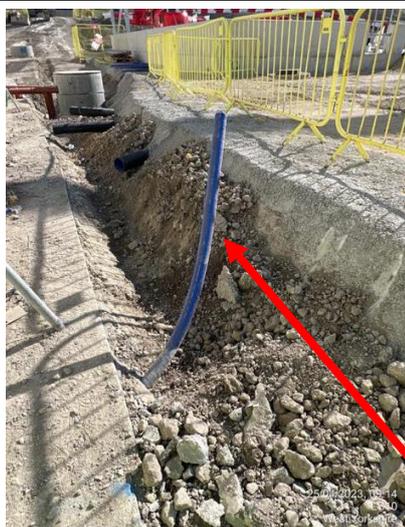
Recently on a UK Construction Site a groundwork operative was preparing a trench for the installation of a 63 mm diameter High Density Polyethylene (HDPE) pipe. The worker had to lay sand in the trench and to do this he decided to move the length of protruding pipe out of the way and hold it with a Heras Fence block. Whilst manually manoeuvring the pipe it slipped out of his grasp. The stored energy in the pipe caused it to spring back to its original shape and its arc of travel meant that it struck him with force in the nose and eye part of the face causing lacerations to the nose. He also suffered lacerations around the eye where his safety glasses had absorbed the impact but pressed against his face.

Line showing where the pipe struck the face

Pipe that sprung back causing injury

- Incorrect planning of the activity by the supervisor or review of the task by the operative highlighting the risks of changes from the documented task.
- Not identifying the potential change to the task by the supervisor during the pre-task briefing.
- The operative not identifying the manual handling requirements involved in moving the pipe and informing his supervisor of the need for two people..
- Handling error (pipe slipping out of the hands) which caused stored energy in the pipe to be released hitting the operative in the face.

- Reinforce and retrain contractors on the use of the Point of Work Risk Assessment (Take 5) and the need to check the work area to highlight any changes from the documented risk assessment
- Provide Manual Handling Training and refresh those trained by way of tool box talk highlighting manual handling requirements
- Re-enforce site PPE rules. It is highly probable that this worker would have lost an eye had he not been wearing standard Light Eye Protection (Safety Glasses). Please remember this if you pass someone on site who is not wearing their safety glasses and politely ask them put them on.

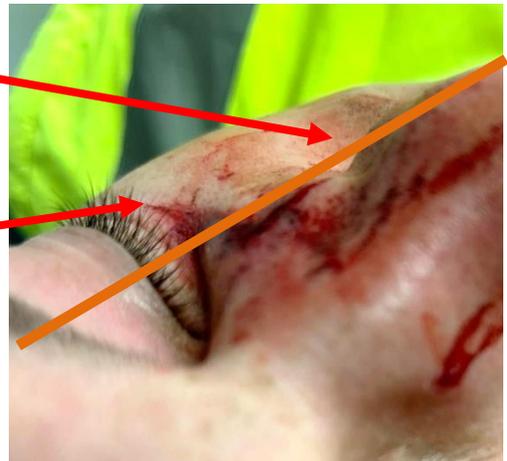
Minor injury caused by the impact on Safety Glasses

Photo taken at the time of the injury and used by written permission of the injured Person
