LTI - Hand crushed

Number	2023-18	Date	21.08.2023
---------------	---------	-------------	------------

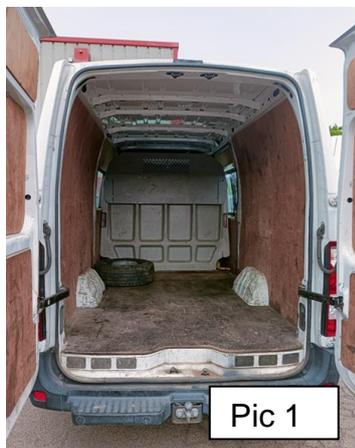
Pic 1

At ESTI warehouse, during the unloading of equipment from the van used on site (**Pic. 1**), an incident occurred when the IP tried to carry alone a toolbox (**Pic. 2**) stored on top of another wheeled box (**Pic. 3**).

Root Cause and Contributory Factors	Action and Lesson Learned
<ul style="list-style-type: none"> • Lack of risk perception • Lack of work preparation • Manual Handling of heavy material 	<ul style="list-style-type: none"> • RAMS to include all steps of the activity, with relevant risks and control measures. • Raise awareness about manual handling and loading / unloading activities. • Use toolbox that can be handled with a forklift. • Use additional trailer with van to limit stacking of material.

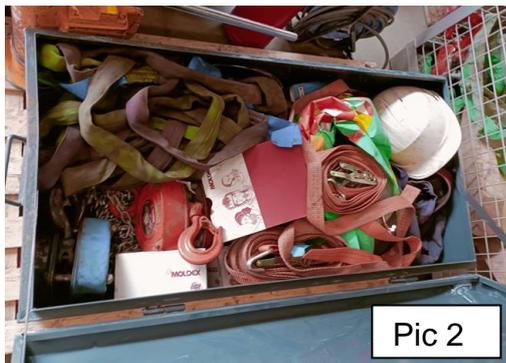
Pic 2

As the IP lifted it by hand, the toolbox slipped. Due to the weight of the toolbox (approx. 110Kg), the IP could not hold it and got his right hand crushed between the toolbox itself and the vehicle wall.
