HiPo LTI RIDDOR: Grating panel fell impacting two workers

Number	2020-01	Date	11.05.2020
---------------	---------	-------------	------------

Recently during the construction of an energy from waste plant securing clips were being attached to Kennedy grating at the 9m level. Whilst lifting one end, an operative mis handled a 1m² section of grating causing the grate to fall the ground level. At the same time two operatives from the same working party thought that the grate installation overhead had finished and entered the exclusion zone below, the grate impacted the two operatives which resulted in both sustaining injuries.

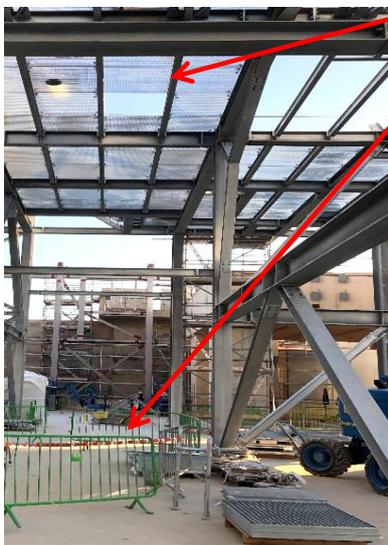
Gap showing missing grate section

Location of injured workers

- Failing to control the Exclusion Zone
- Poor storage of material
- Poor communication between working parties on the 9m level and on the ground floor.

- Failing to identify risk of Drop Objects when mistakenly entering the Drop Zone.
- Deviation from agreed method of installation of the grating section.

- Make clear by way of whole site briefings the difference between Work Area Exclusion Zones where entry is permitted to authorised personnel and a Drop Zones where entry is forbidden and any breach will result in disciplinary action.
- Ensure all Drop Zones are put in place and approved by HZI. They can then only be removed by Contractor Supervisors who annotates the POWRA.
- Ensure specific Drop Zone warning signs reporting “risk of drop objects” and “Do not enter” are posted along the Drop Zone fence.
- Ensure that the extent of the Drop Zones and disciplinary consequences of entering one are briefed every shift on the POWRA
- Never store material inside a Drop Zone

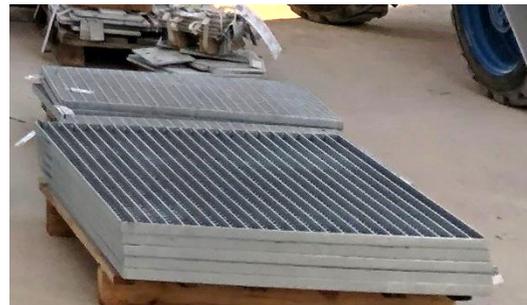
Examples of grating section that fell
