LTI – Anröchte System and Service Project – Cut on finger

Number	2023 - 04	Date	15.03.2023
---------------	-----------	-------------	------------

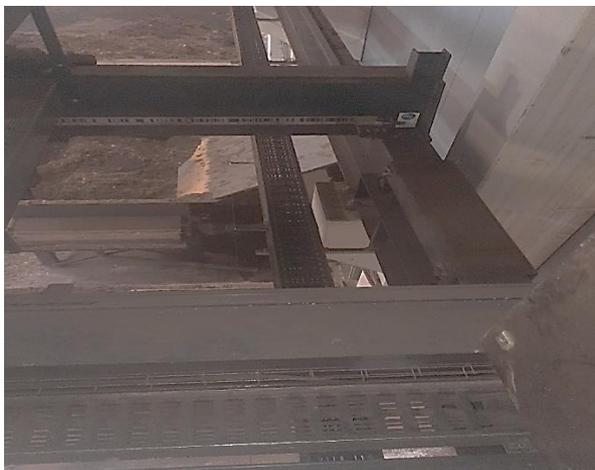
Summary: On March 15th 2023, a worker from a HZI contractor was conducting maintenance activities on the waste crane on Anröchte project in Germany. As a last step of the task, the worker needed to carry out a final clean-up of a cable duct of the waste crane. The clean-up involved using a hand brush. During the cleaning operation the worker's finger came into contact with a sharp edge and sustained a cut which required medical attention.

Picture 1 - Detail of the Cable Duct which was being cleaned

- Ensure that all risks are identified, controlled and detailed in the relevant RAMS. Also that they are shared with the team using the POWRA.
- Ensure that right PPE is identified and provided to the workforce, according to the requirements of the RAMS.
- Provide sharp edge protection, where applicable.
- Always ensure HZI supervision present at site.
- Ensure that all workers have attended the relevant HSE Induction training.

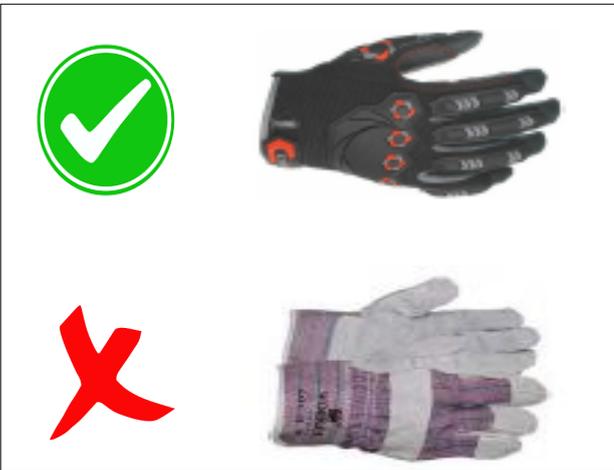
Picture 2 – Right cut-protection Glove vs. Wrong Generic leather Glove

- Lack of risk perception (the hazard of sharp edges was not taken in account).
- Lack of work preparation (cut-resistant gloves were not specified in the RAMS nor available for use by the worker)
