HiPo NEAR MISS – STEEL SECTIONS FELL FROM TRUCK WHIST UNLOADING

Number	2023-06	Date	17.04.2023
---------------	---------	-------------	------------

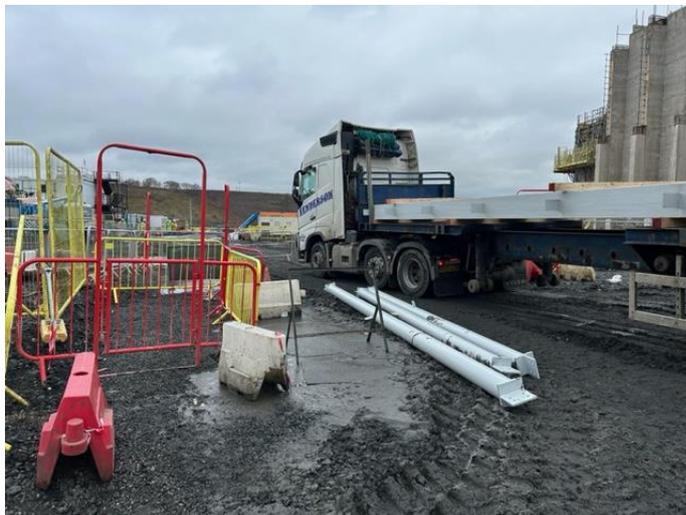
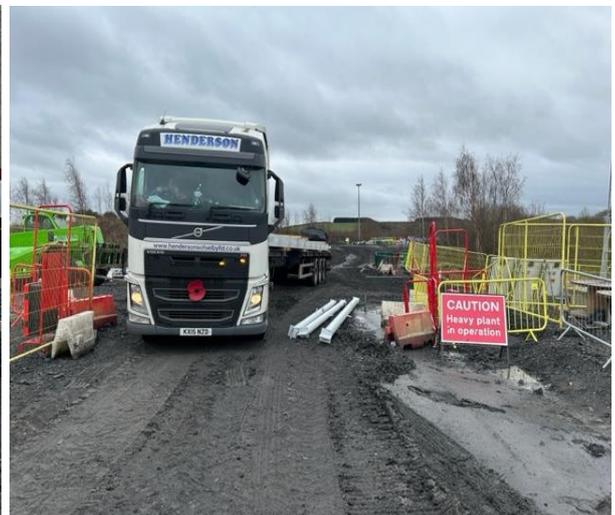
Recently on a UK Construction Site a delivery of steel sections had arrived on site on an articulated lorry. The lorry parked up in the construction area and the driver completed an offloading check sheet. Although no pedestrian exclusion zone was established around the truck the driver started to remove the straps holding the load. As he was removing the straps three round beams weighing between 120 and 200 kg rolled along their wooden packing pieces and fell to the ground.

No one was in the area, no one was injured and there was no significant damage to materials. The near miss was classified as a HiPo because there was no effective pedestrian exclusion zone around the vehicle.

Root Cause and Contributory Factors	Action and Lesson Learned
<ul style="list-style-type: none"> • Failure to follow procedure namely Contractor's Site Unloading Check Sheet and the Contractor's Loading Procedure. • Site Unloading Check Sheet completed incorrectly, and specific controls not followed. • Not using wedges and king posts for transport of round steel sections. • Lack of mutually agreed suitable offloading area. • No Permit to Work issued for offloading activity. 	<ul style="list-style-type: none"> • Contractor to revise Unloading Check Sheet to make easier to follow. Brief those involved in unloading activities that it is mandatory to correctly follow the controls specified in the Contractor Check Sheet (notably the establishment of exclusion zone). • Loading Procedure to be reviewed, communicated, and adhered to. Contractor to communicate with hauliers and sub-contractors to ensure improved securing of materials during loading and transporting at location of loading. • Include offloading activity in the daily coordination meeting, agree a safe area and issue a permit. • Ensure that the allocated offloading area is flat and accessible.
